Characterising alpine peatland water quality on the Bogong High Plains, Victoria

In brief

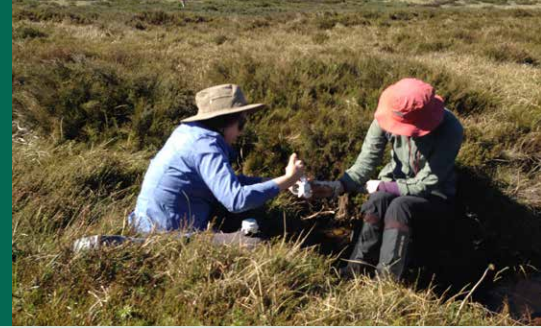
RIGHT: Researchers taking water quality samples at a peatland in the Bogong High Plains.
Image: Joslin Moore

Measurements were made during normal conditions without rainfall. We evaluated whether these properties reflected the previous condition assessments made by experts. We measured peat depth and surface water parameters in the field (dissolved oxygen, pH, turbidity, temperature and electrical conductivity), and collected water samples for analysis in the laboratory. We measured these water samples for levels of phosphate, nitrate, nitrite and

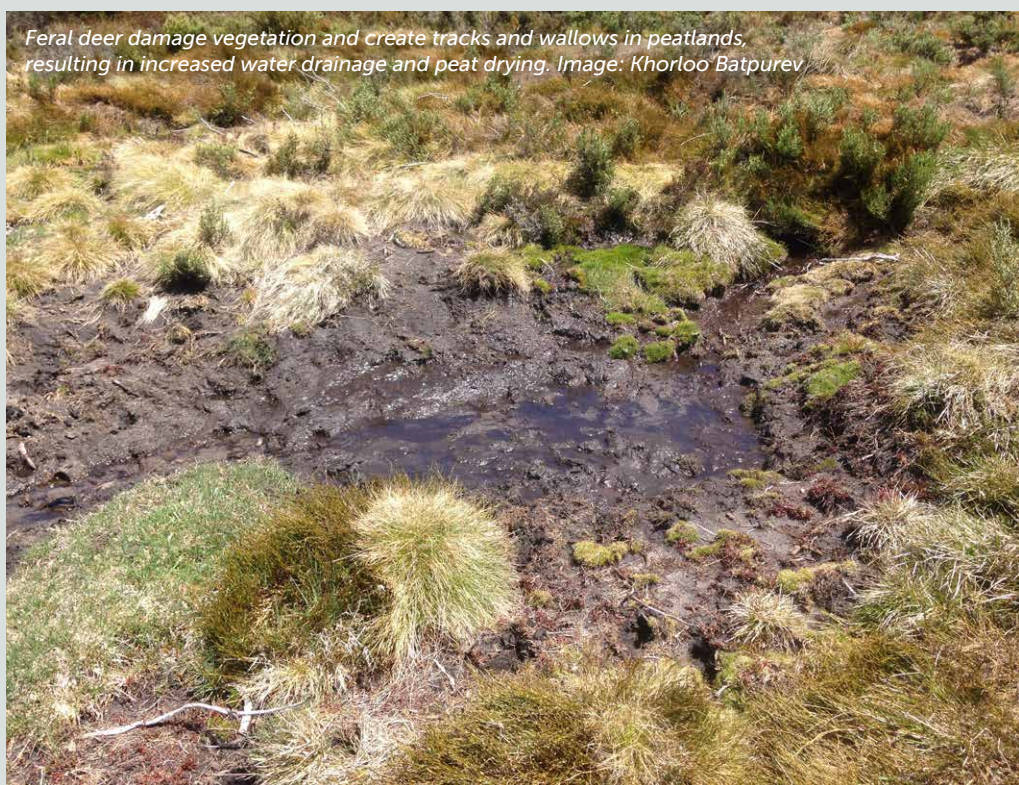
Feral deer damage vegetation and create tracks and wallows in peatlands, resulting in increased water drainage and peat drying. Image: Khorloo Batpurev
